Intel[®] Pentium[®] III Processor Specification Update

Release Date: December 2002

Document Number: 244453-046

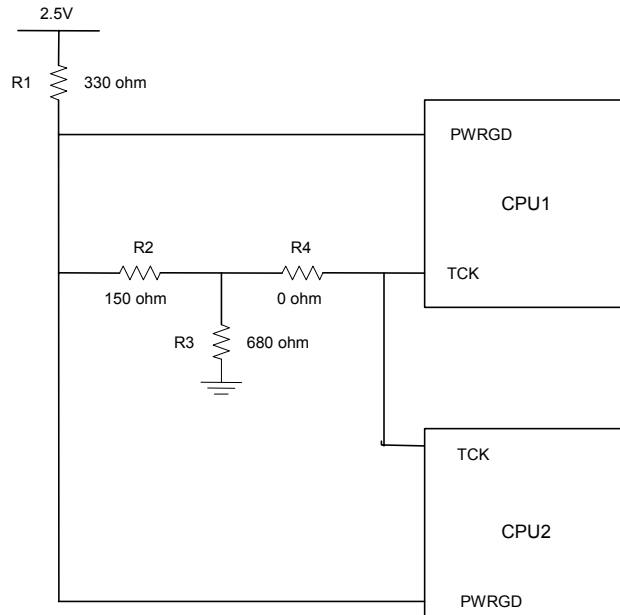
Pentium® III Processor with 512KB L2 Cache Platforms Workaround

Assumes the inputs to the CPU_PWRGD are open collector signals that are Wire-ANDed together

- The example workaround circuit assumes that the PWRGD inputs into the processors are open collector. Tying the PWRGD inputs together in a Wired-AND fashion allows each processor to receive PWRGD at the same time but at the latter of the 2 separate PWRGD assertions. If separation of the PWRGD inputs to each processor is required, extra circuitry will be required.
